# URSA MAJOR INCIDENT COMMUNICATION

### Propane Tank Dropped From 30+ Feet

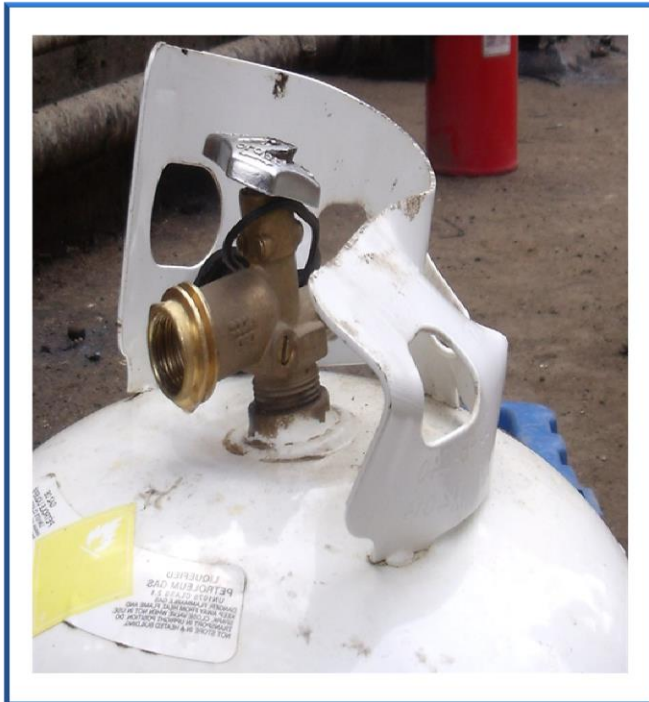
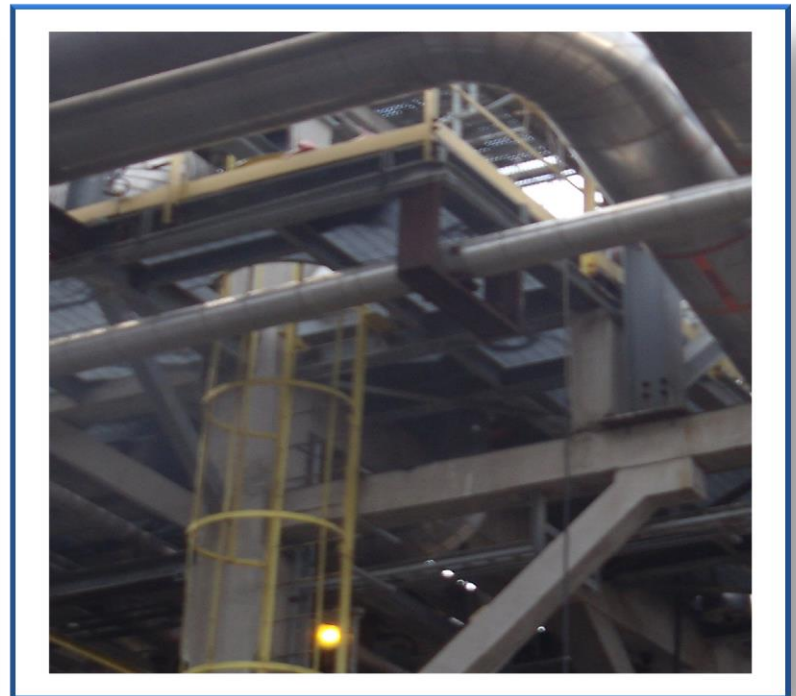
- Pipefitters were hoisting a 20 lb. propane bottle with a rope to the top of 7-1 structure when the knot let go causing the propane bottle to fall approximately 30+ feet to the ground level.

- **Standards / Policies / Procedures Not Followed** – Employees and supervision did not follow the policies and procedures in regards to handling and hoisting of compressed gas cylinders.
- **Poor Job Planning** – Supervision / employees did not plan the job utilizing the policies and procedures that applied to the task.

- **Inadequate Hazard Assessment** – The hazard assessment failed to identify the hoisting a compressed cylinder with a rope as a hazard.
- **Inadequate FLRA/SPA Card** – The FLRA/SPA card did not recognize rigging a propane tank as a task step, resulting in a lack of identification and control of rigging hazards.

- Tanks will be left on ground and longer hoses utilized.
- Any and all lifting of compressed gas cylinders must be done with approved lifting baskets.
- Workers and supervision to be educated on handling of compressed gases and hazard identification.
