# URSA MAJOR INCIDENT COMMUNICATION

Employee fell into a 3ft boot inside C-4 vessel

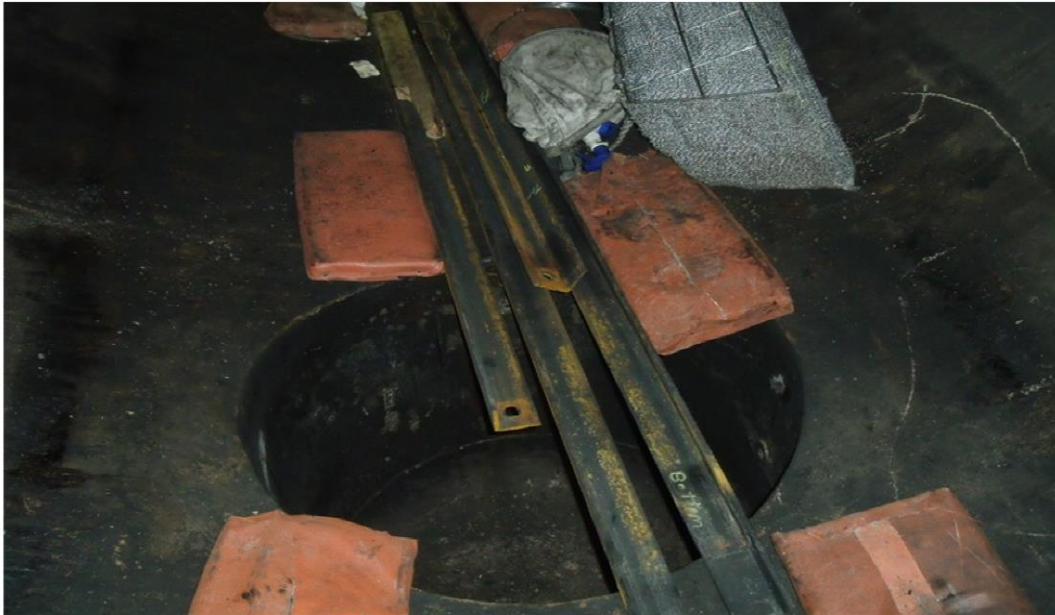
- While installing demister pads in plant 7-1 C4 vessel, Employee walked to the rear of the drum and fell into unmarked open hole 3' deep.

- **Unclear or incomplete instructions between others (Supervisors, contractors, clients, etc.)** - Jacobs foreman asked scaffolders to remove scaffold for inspection of the boot by client QA. In doing so they left an open hole / leading edge hazard.
- **Inadequate evaluation of change in work scope / plans** - The foreman did not recheck the working areas for their personnel before assigning them work. In this case the foreman assumed the barricade was replaced.
- **Inadequate illumination** - The work face was well lit, however the rest of the vessel had poor lighting.

- **SPA did not address all hazards associated with the task** - Open hole was not assessed on the SPA.
- **Lack of evaluation of hazards or mitigation options** - No mitigations were put in place for the open hole, as it was not discovered during the hazard assessment.

- Ensure that all open holes and leading edges are properly barricaded.
- Set up work areas with proper lighting.
- Coach workers on hazard identification and mitigation options.

- The SPA did not adequately identify the task steps and hazards associated with the job. Workers need to be coached and mentored in hazard assessment, elimination and control.
- Supervision failed to verify the work area was safe prior to sending the workers back to the area. Foreman need to inspect work areas prior to accepting work and sending out the workers.
- Increased field presence by supervision combined with additional coaching in hazard assessment is required. Continual compliance monitoring will ensure that any deficiencies can be addressed before an incident occurs.
- Scaffolders need to ensure that open hole / leading edges are adequately protected before leaving the area.
